FIVE X FIVE SERIES (projects smaller than 25 sq.m.)

New Pergola: West End, Hampshire completed Summer 2008

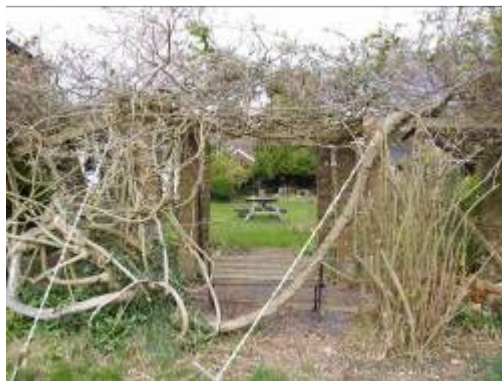
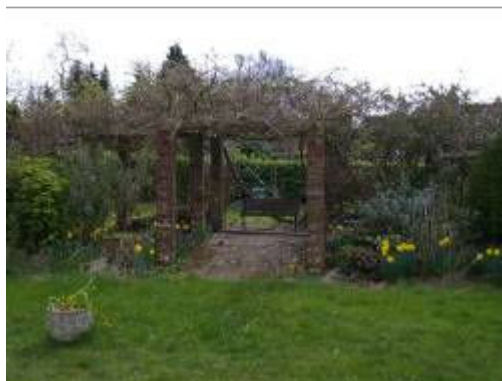
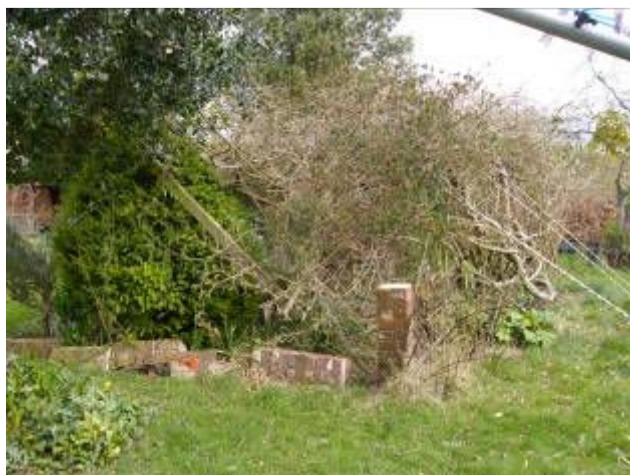
Over time the *Wisteria sinensis* had caused severe strain to part of the structure and despite a number of repairs over the years, the structure was in a seriously unstable state, with some collapsed pillars. My client was loathe to destroy the *Wisteria* and felt that the pergola structure was an interesting feature to have in the garden.

< ^ **BEFORE:** This half-century old brick pillar pergola is slowly being crushed by the weight of the mature *Wisteria*

I proposed that we replace the whole structure and rebuild in oak with proper bracings and to a new, more balanced (cruciform) design. This would preserve the alignments of the pergola in relation to the rest of the garden and the interesting tiling and brickwork under the pergola.

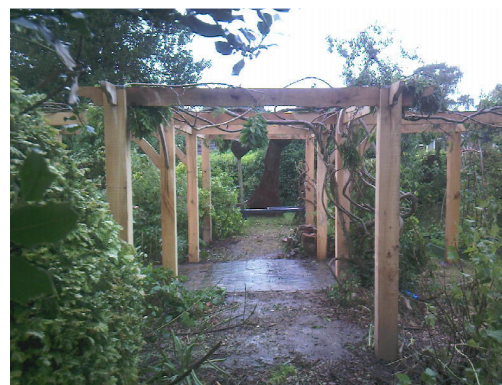
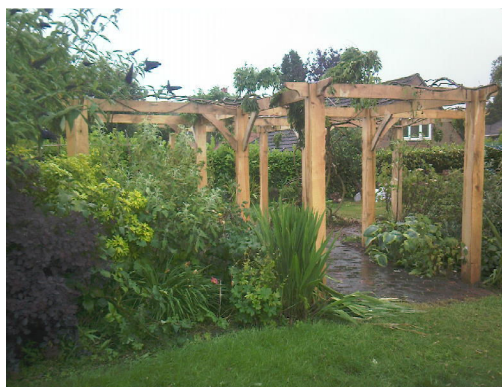
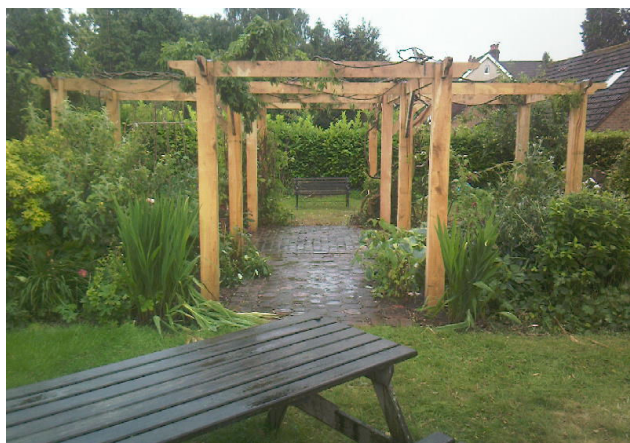
v> **AFTER:** the decision was taken to demolish the brick pillars and completely rebuild the pergola frame in oak, in a new, larger cruciform shape

At the same time, we gave the *Wisteria* a severe pruning so that it could be retrained to spread more evenly across the structure. Surrounding planting areas were largely unaffected by the works. The contractors worked closely with the client on site to develop the final details of the pergola design and the restorative pruning activity of the *Wisteria* in preparation for retraining over the structure.
